approach

NAVAER 00-75-510

THE NAVAL AVIATION SAFETY REVIEW

MARCH 1957

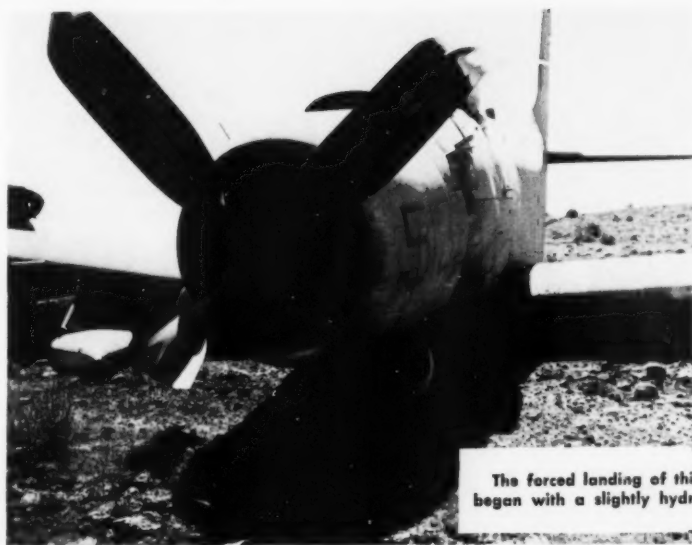
The forced landing of this AD was caused by an engine failure which began with a slightly hydraulicked rod . . .

Let's look at a recent series of engine failures which when investigated definitely pointed to "hydrauliccking" due to liquid locks.

The flight handbook spells out a desired number of blades to be turned through before starting the engine. When this procedure is not followed rods can be broken. Even more serious, they can be bent so that hours hence failures occur, most often to pilots who inherited the conditions from predecessors who had neglected to pull their props through with the starter.

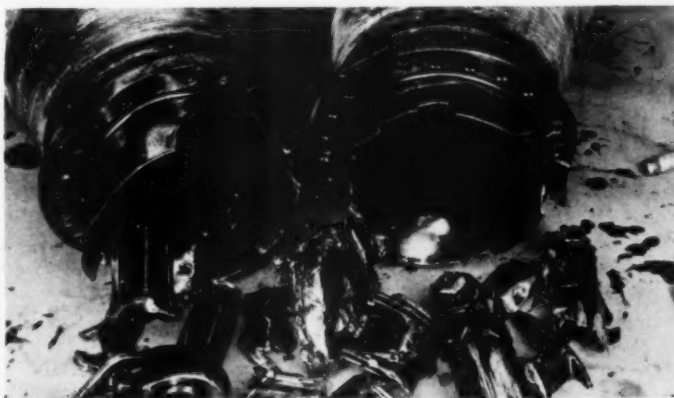
. . . Later, piston rings were driven below cylinder skirt during high power output causing complete power failure.

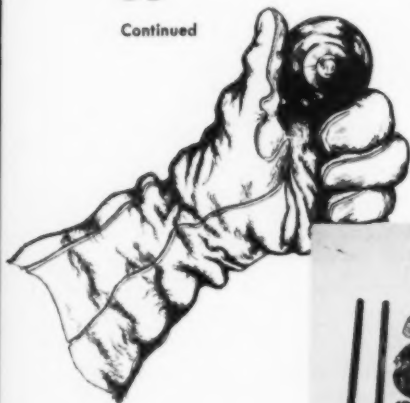
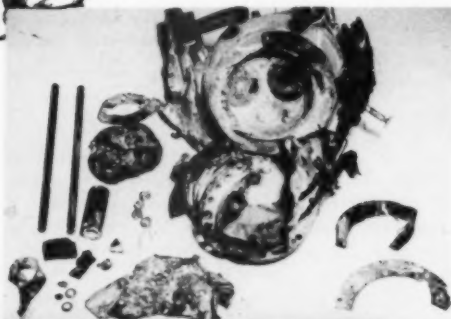
Broken accessory and starter drive shaft (left) of R3350 was attributed to improper shifting of blowers. Excessive BMEP caused cylinder at right to separate from crankcase.

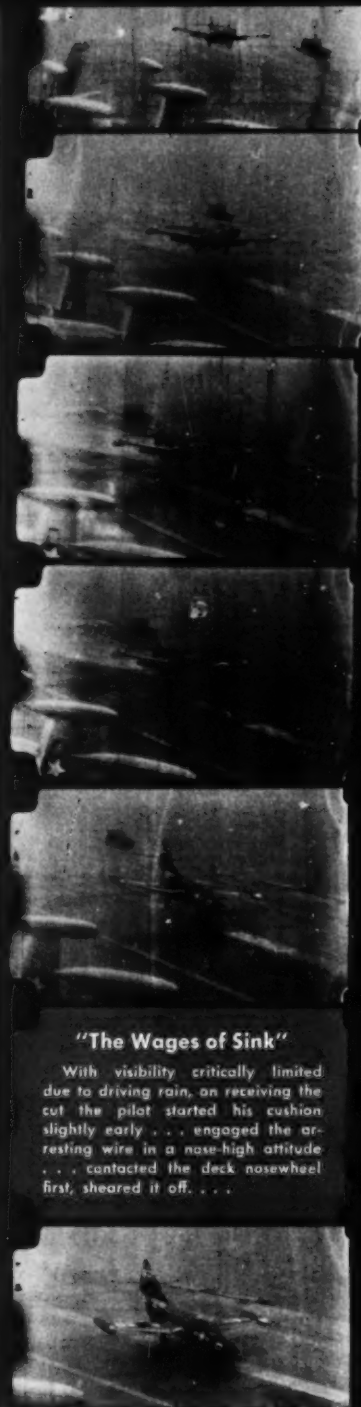
"The Wages of Sink"

With visibility critically limited
due to driving rain, on receiving the
cut the pilot started his cushion
slightly early . . . engaged the ar-
resting wire in a nose-high attitude
. . . contacted the deck nosewheel
first, sheared it off. . . .

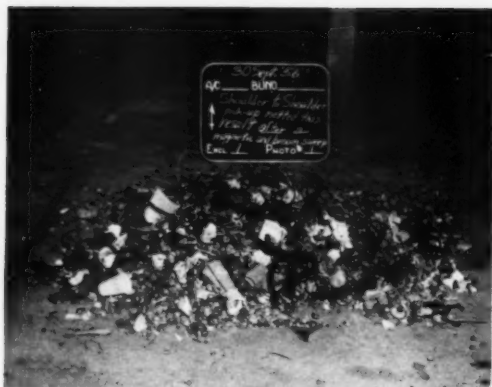
Shoulder-to-shoulder pickup netted this result after a magnetic and broom sweep.

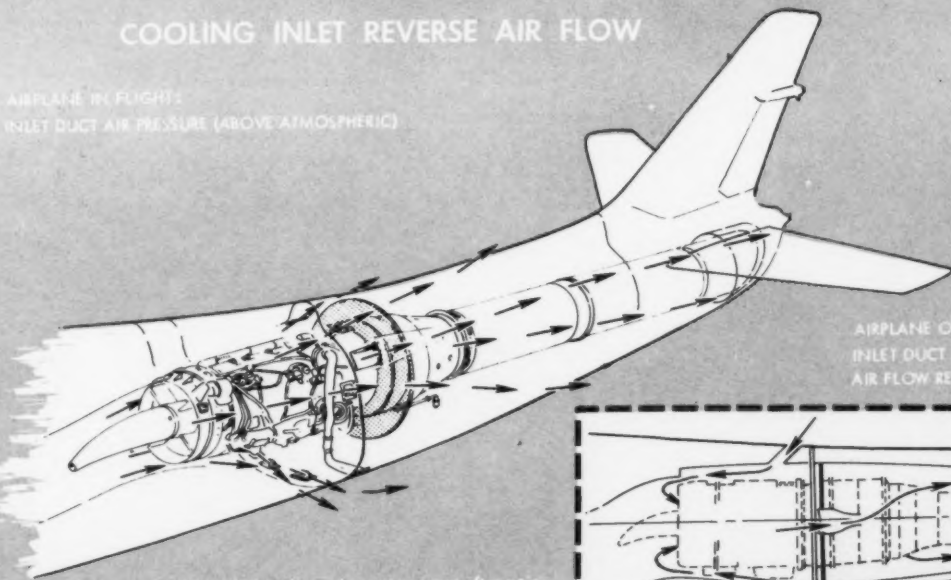
AIRPLANE IN FLIGHT:
INLET DUCT AIR PRESSURE (ABOVE ATMOSPHERIC)

Loose objects left in the engine compartment after maintenance can be picked up by this airflow and carried into the engine.

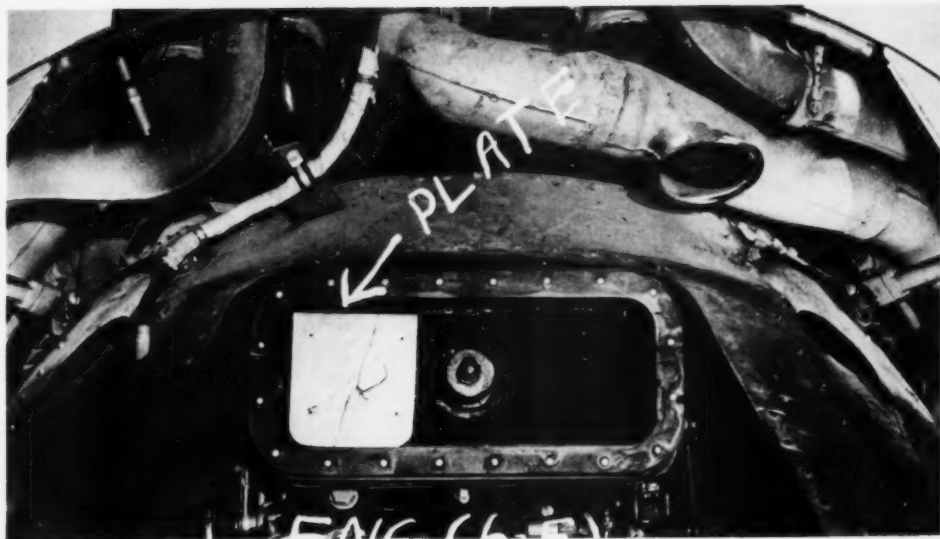
This metal plate, choked an AD engine to "death," and a major accident resulted.

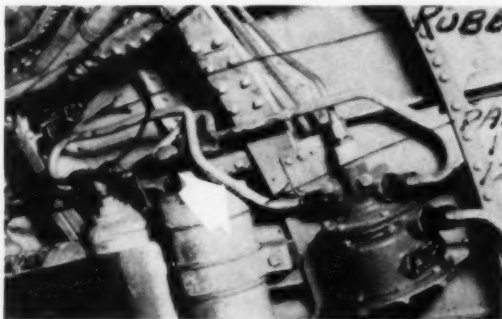
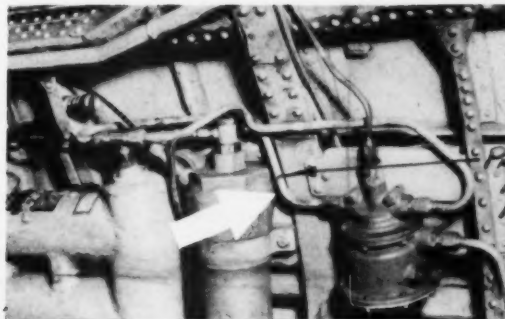
This "Murphy" pertains to F9F-6, -6P, -7 and -8 aircraft. A restriction of the elevator control cable on an F9F-6 aircraft occurred during preparation for flight. Investigation revealed the quick-disconnect, Part No. RA-2248-6 on the elevator down control cable rubbing and binding on an incorrectly installed plenum chamber hydraulic system pressurization line, Part No. 177500-1299-RP6. Refer to F9F Aircraft Service Change No. 336 page 13 for view of hydraulic line arrangement. Photo No. 1 shows the line incorrectly installed. Photo No. 2 shows the line correctly installed.
